Hollyday House
131 North Washington Street
Easton, Maryland 21601

T-25
First Quarter
Nineteenth Century

INVENTORY FORM FOR STATE HISTORIC SITES SURVEY

Hollyday House

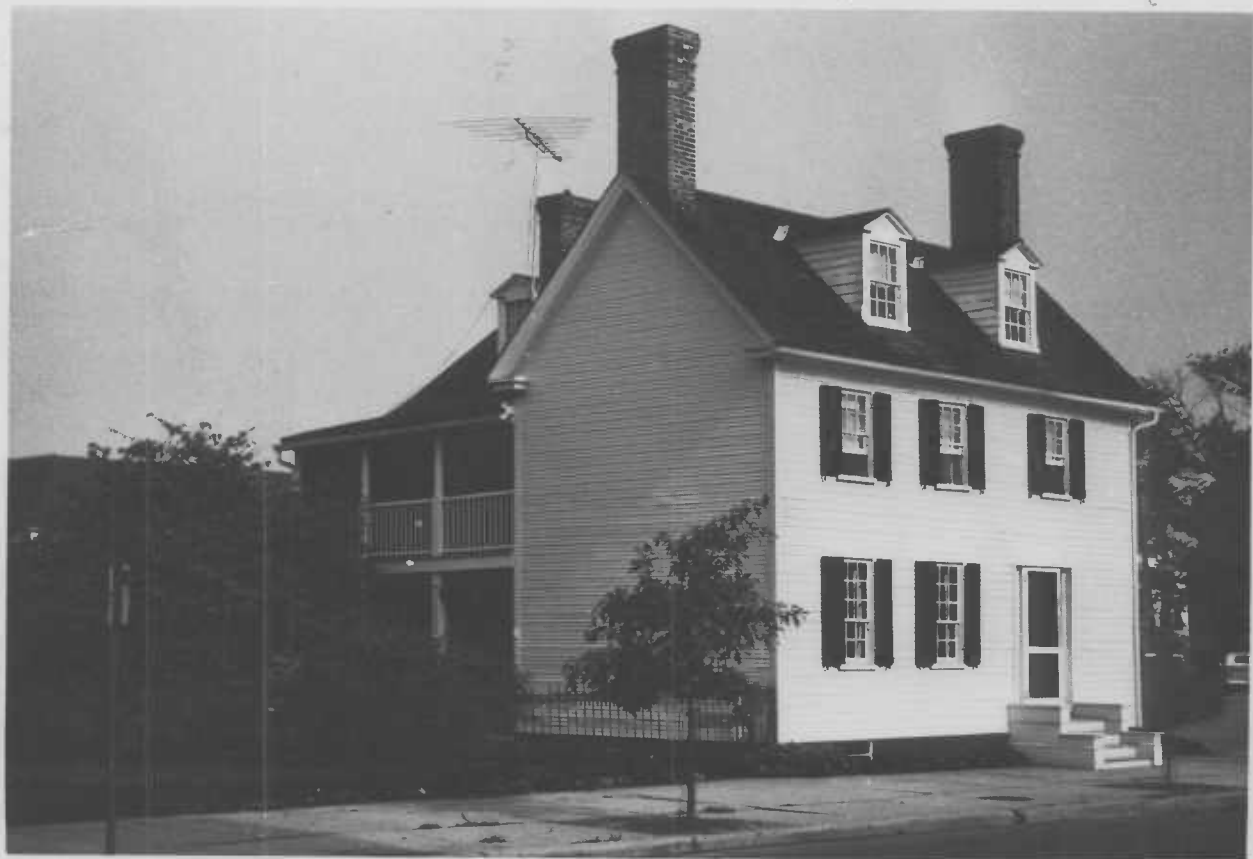
View to NW

#131 North Washington Street, the Hollyday House, is a delightfully proportioned frame house which may have once been a tavern. Its unusually tall chimneys and steeply pitched roof give this diminutive building a lively, picturesque quality. The house stands on the west side of North Washington Street at the edge of Easton's new commercial district.

The building is three bays wide and two-and-a-half stories high with two gable dormers in the east roof slope. The brick chimneys are enclosed within the end walls and have corbelled caps. To the rear of the main house is a two-and-a-half story wing which appears to have been lengthened one bay. At the original rear exterior wall is another brick chimney which closely resembles those of the main house block.

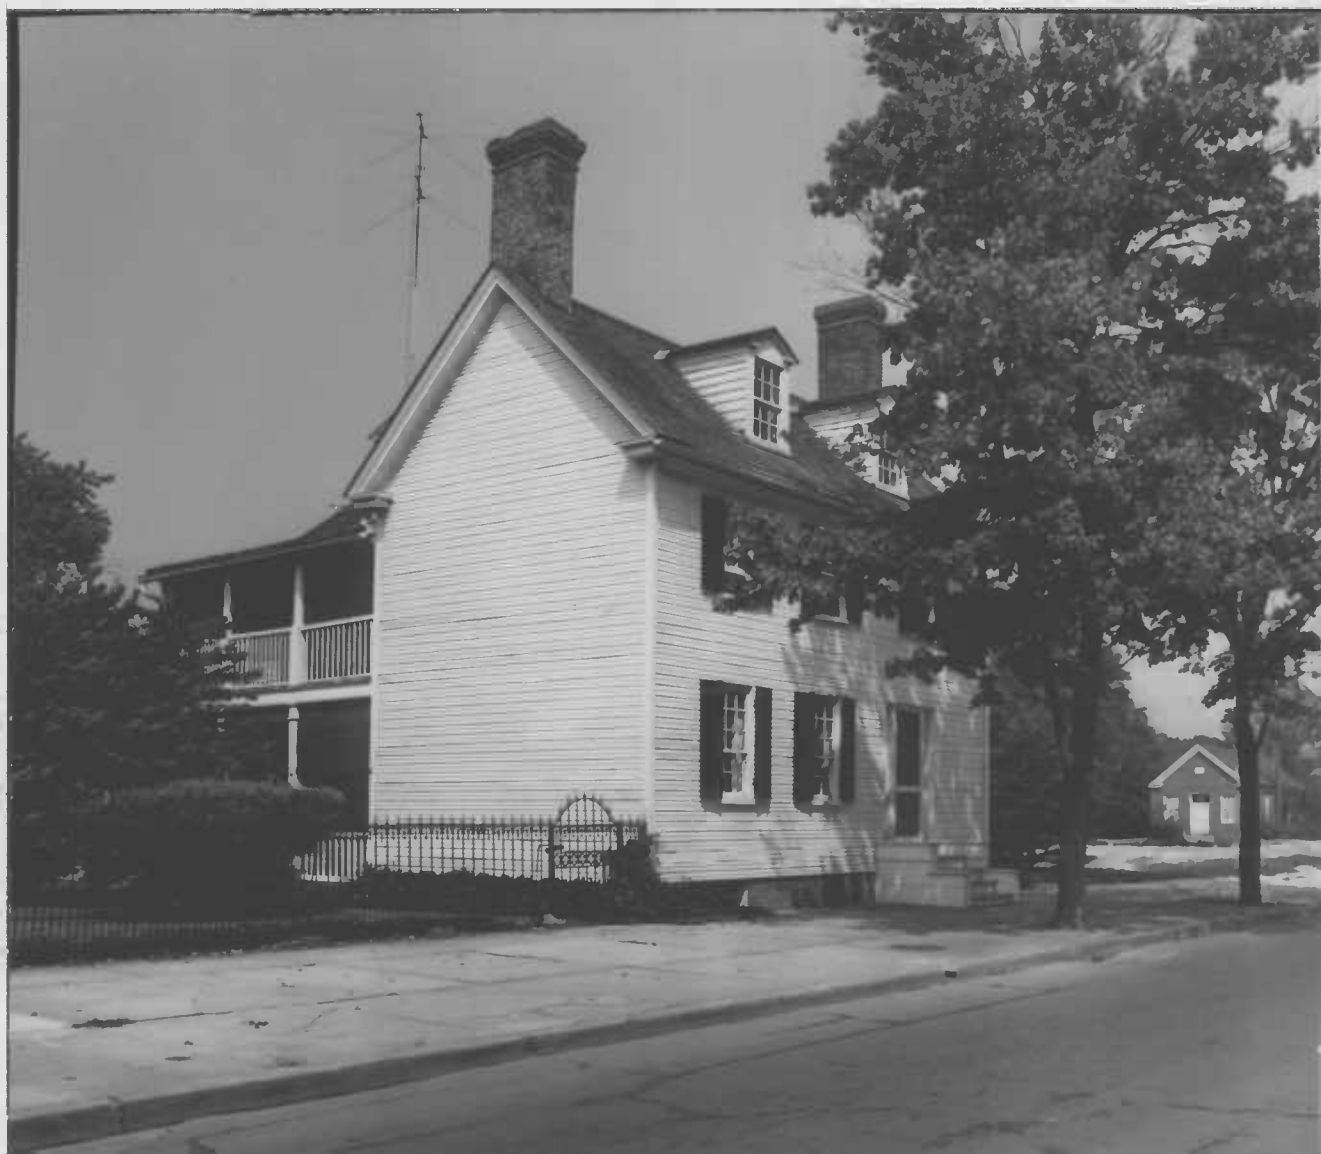
Southeast Facade

Windows of the main house have nine over six sashes on the first floor and six over six sashes in the second floor and the dormers. Trim has a backbond molding and plain, unmolded wooden sills, louvered shutters, painted black, are used. The main entrance has sidelights and is reached by a flight of three wooden steps. The door itself has flat molded panels and appears to date from the second or third quarter of the nineteenth century.
